AUGUST, 2022

ENSURE STRICT APPLICATION OF NAVIGATIONAL PROCEDURES

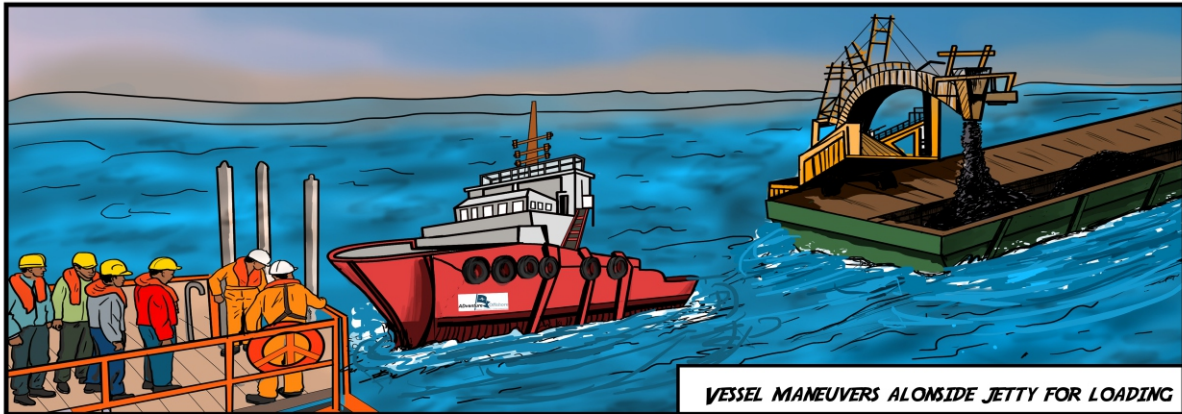
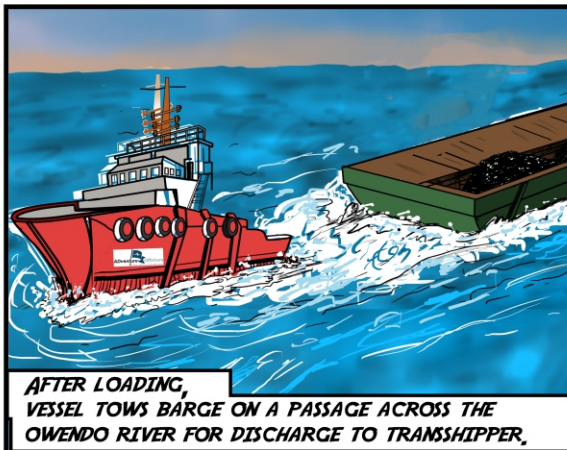
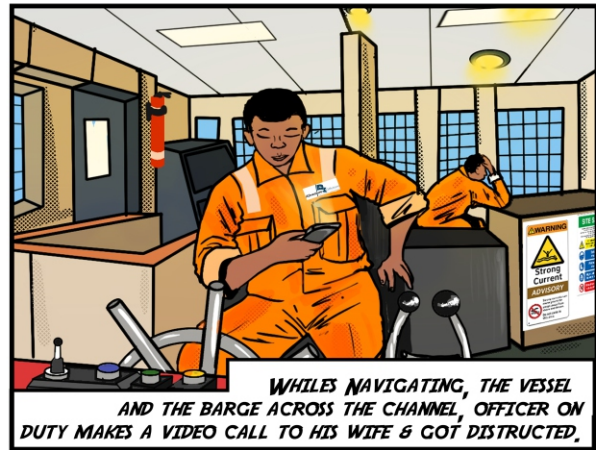
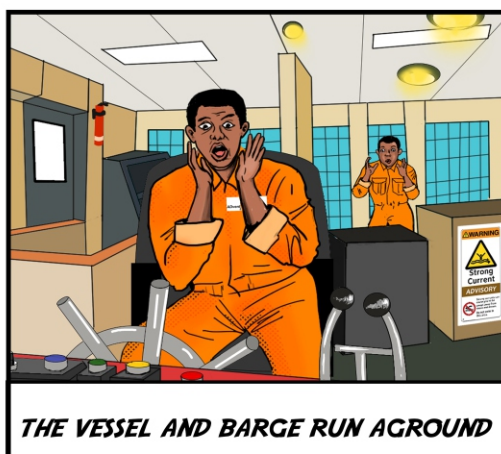
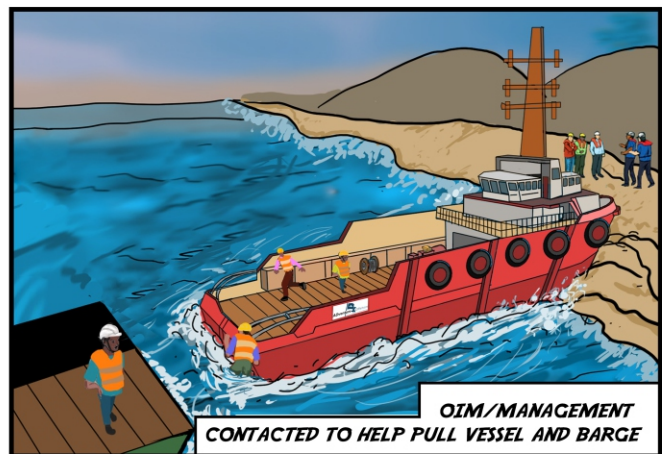
This Event occurred during a night transit from the comilog jetty to TSA area. Master left the bridge and duty command to the officer on watch without ensuring vessel, crew and cargo was safe. The vessel was inside and narrow owendo river channel with shallow water on both port and starboard side with the tide of six knots when master left the bridge resulting in vessel running aground.

Gaps Identified: Passage plan and Navigational Code was not respected, Watch keeping was not adapted, sailing speed to environmental conditions was not adapted.

DO: 1. Follow guidelines on navigational code and procedures for the safety of vessels, personnel, Cargo and the environment

2. Tug Masters are ultimately responsible for the safety of navigation.

3. Vessel should be navigated in compliance with COLREGS all the time.

4. Masters SHALL be responsible for all vessel maneuvering in a timely manner to avoid creating potencial close quarter situations with full and complete regard for prevailing current and other weather condition, shallow waters, fix object and traffic density.

DON'T: 1. Do not forget to apply the Stop Work Authority, if Conditions do not enable to operate safely
